Journal of Cardiovascular Medicine and Cardiology

Case Report

A Case of Balloon Rupture Cause Serious Complication during Percutaneous Coronary Intervention

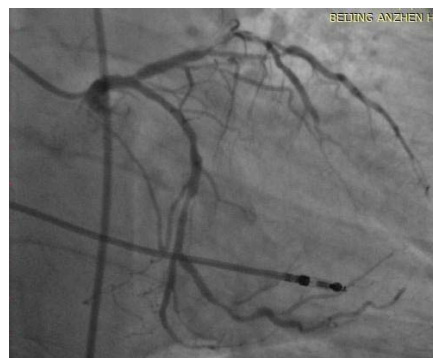
Figure 1: Balloon rupture during second dilation.

Patients were treated with PCI. Through 6F XB 3.5 guiding catheter, REGATTA guide wire was sent to the distal LAD, Runthrough guide wire was sent to the distal D, the mid LAD lesion was dilated with the B. Braun Melsungen 2.0mm×20mm balloon at 20atm. Balloon rupture occurred on the second dilatation at 20atm, leading to extravasation of contrast agent, coronary artery dissection and subintimal hematoma, dissection and hematoma extended to D, the distal left circumflex (LCX) and the proximal LAD. Cordis guide wire were immediately sent to the distal LCX, the Medtronic 2.25mm×18mm stent was deployed into the middle of LAD with the pressure of 16atm, Boston Scientific 2.25mm×32mm stent was deployed from OM3 to the mid LCX with the pressure of 14atm, entrance and exit of the dissection and hematoma were all blocked, and the dissection and hematoma was not visible. Then Cordis 2.5mm×10mm balloon was inflated to 26atm inside the LAD stent, Boston Scientific 2.25mm×12mm stent was released in the distal LAD at 10atm, the angiography showed that the stenosis was relieved, the blood flow was TIMI-3, there was no hematoma and dissection, and the patient was stable after operation.

In this case, the cause of the balloon rupture may have the following aspects: 1) the pressure of balloon dilation was too high; 2) the patient had severe coronary artery calcification; 3) undetected gas was in balloon when balloon dilation; 4) balloon had quality problem. We should pay attention to these risk factors and it is significant for patients to deal with coronary artery dissection and subintimal hematoma timely, reasonably and accurately.

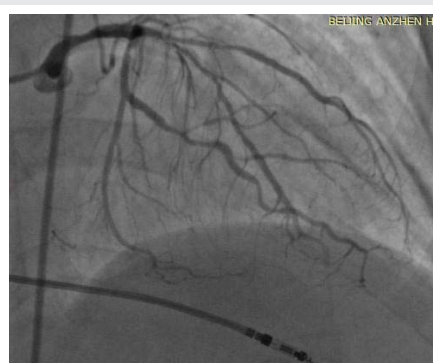
Figure 2: Dissection and hematoma caused by balloon rupture.

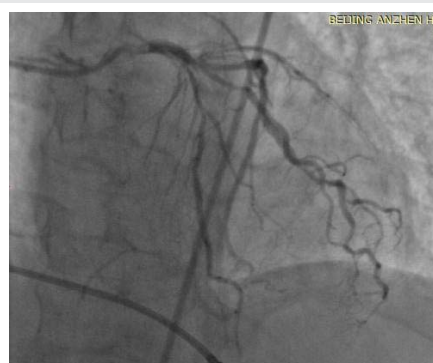
Figure 3: LCX occlusion due to the extension of the hematoma.

inhalation and intravenous access. Seventeen minutes later, the patient experienced loss of consciousness and ECG showed ventricular fibrillation. The patient recovered consciousness after defibrillation and simple ventilator assisted breathing, blood pressure was 80 / 50mmHg, then the patient was turned into the cath lab for emergency PCI. After the patient entered the cath lab, ventricular fibrillation occurred again. Defibrillation treatment was performed for the second time, the patient received PCI treatment under continuous chest compression. After puncturing the right femoral artery, the 6F JL4.0 guiding catheter was placed at the LCA opening, coronary angiography showed LCX occluded, LAD still had blood flow. Runthrough guide wire was sent to the distal LCX, another Runthrough guide wire was sent to the distal LAD, the Medtronic 2.5mm × 15mm balloon was carried retracement, coronary angiography showed the mild LCX hematoma extension made LCX occluded, Medtronic 2.5mm×15mm balloon was dilated at 8-10atm from the proximal LCX to the LCX stent, coronary angiography showed that the blood flow of LCX recovered. Then puncturing the left femoral artery, intra-aortic balloon pump (IABP) balloon was implanted into the descending aorta, heart rate restored to 40 times per minute. Then the operator sent PACEL temporary pacing catheter to the right ventricular apex, the patient received temporary pacing therapy with frequency of 80 times per minute. During the treatment, the patient was given intravenous injection of 1mg epinephrine and 1mg atropine, and was given intravenous drip of 5% sodium bicarbonate, blood pressure was remained at 80-100mmHg, about 20 minutes later the patient recovered spontaneous cardiac rhythm, blood pressure rose to 80-120/40-70mmHg. Coronary angiography showed the blood flow of LAD and LCX restored. Considering possible hematoma extension of the LCX, the Medtronic 2.25mm×18mm stent was placed into the proximal LCX with the inflation pressure of 10atm, the LEPU 2.75mm×18mm stent was placed into the proximal LAD with the inflation pressure of 14atm, the LEPU 3.5mm×15mm stent was placed from LM to LAD with the inflation pressure of 18atm, the angiography showed that all stents achieved good apposition to the wall, the blood flow was TIMI-3, there was no hematoma and dissection. The LCX opening was mild involved, considering the possibility of dissection may occur, so we did not perform kissing dilation. After operation the patient was transferred to the CCU ward for further treatment Figures 1-4.

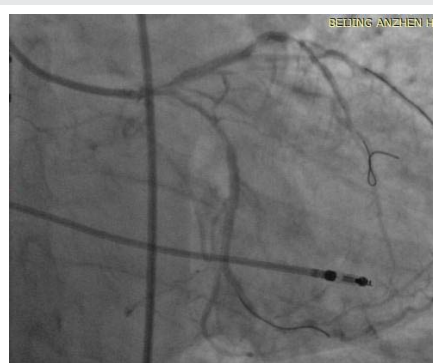
Figure 4: Final angiographic results.
